Factory : Fenghe Plastic and Silk Flower Products
Factory
Auditor Team: Lyn Li

Report No.: HKSZX1736621

Audit Date: May 15, 2012

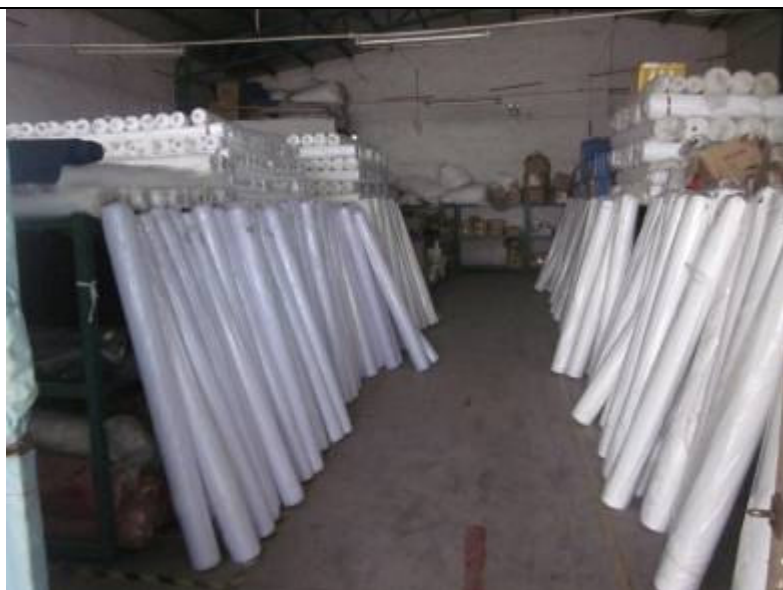
Fabric warehouse/Partly fabrics stored on floor directly

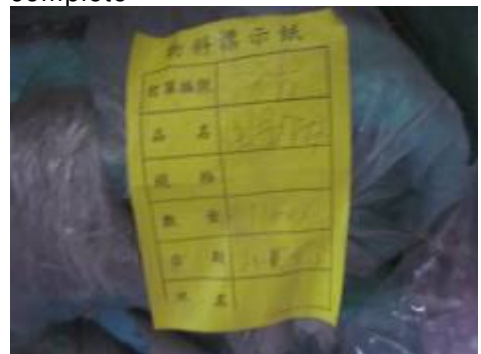
Identification information was not complete

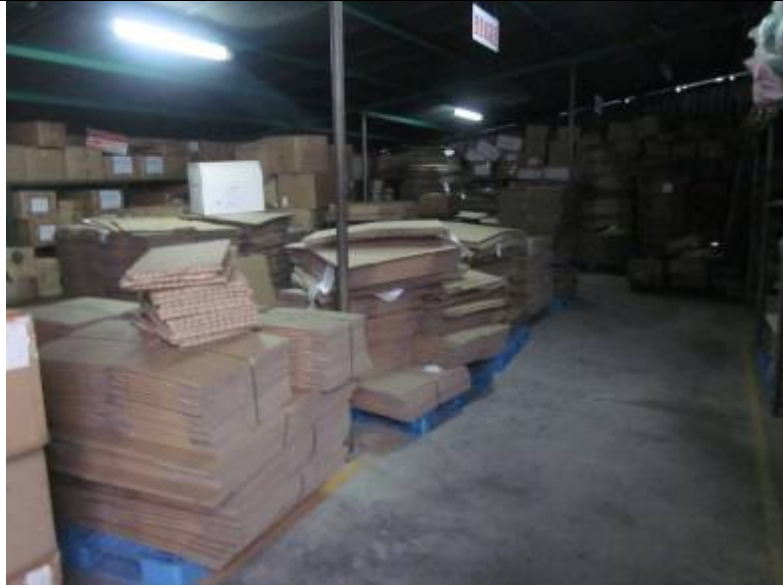
Raw materials warehouse

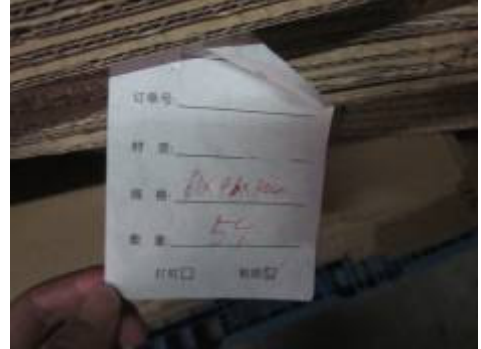
Identification information was not complete

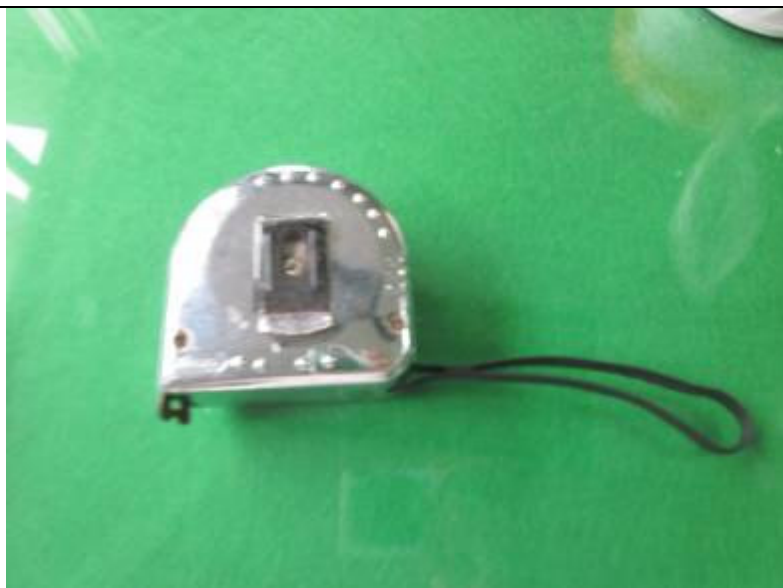
Ruler without calibration

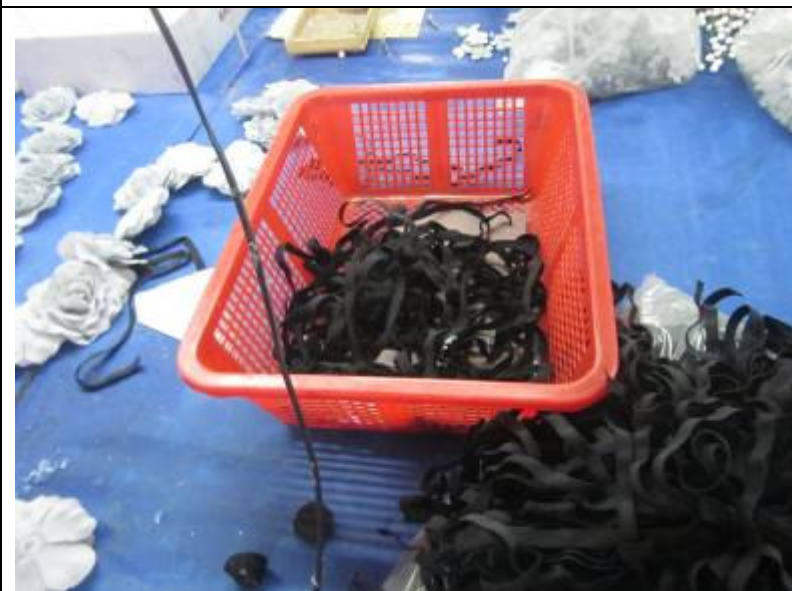
Non-conforming materials were separated with red box

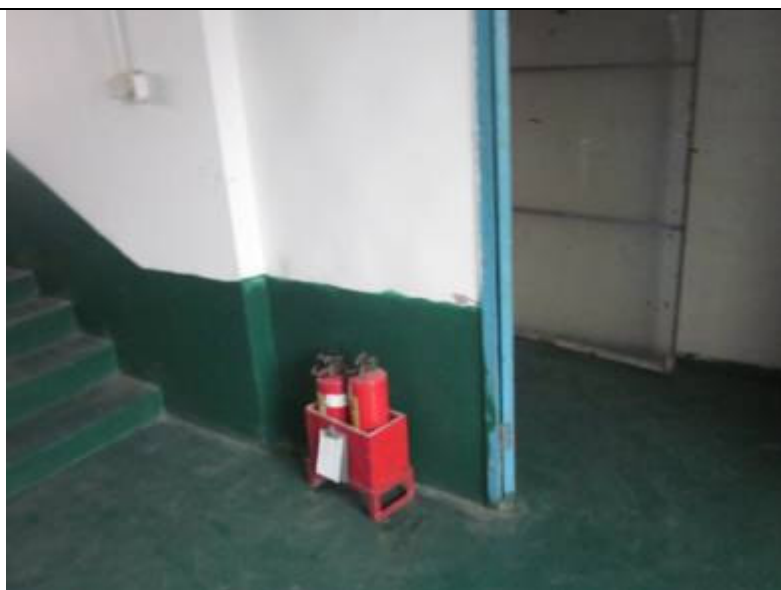
Fire fighting equipments were available on site

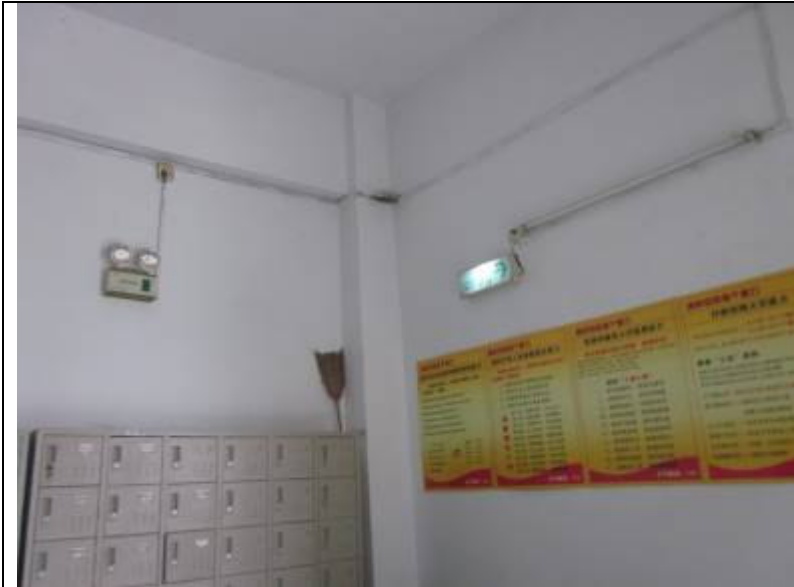
Emergency lights and exit indicated sign
